REPORT OF THE MISSISSAUGA RAILWAY ACCIDENT INQUIRY

The Honourable Mr. Justice Samuel G.M. Grange,
Supreme Court of Ontario,
Commissioner

December 1980

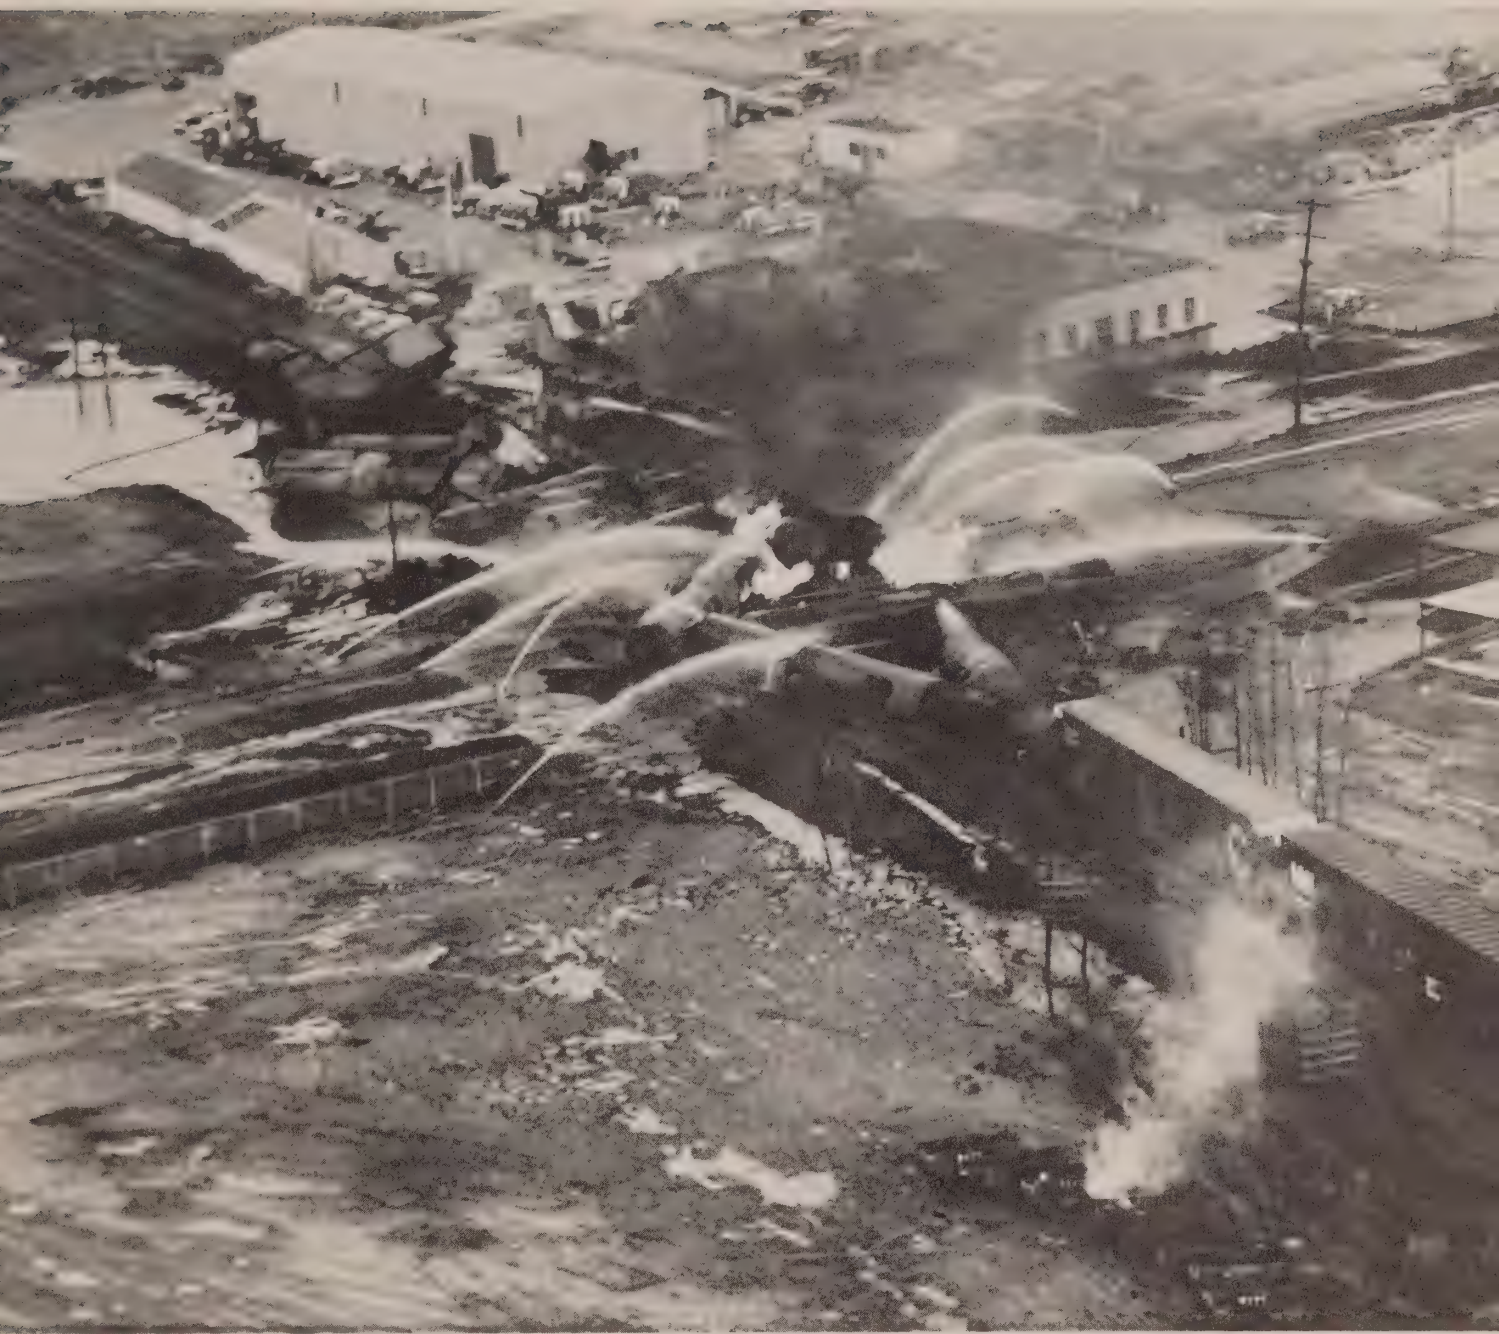
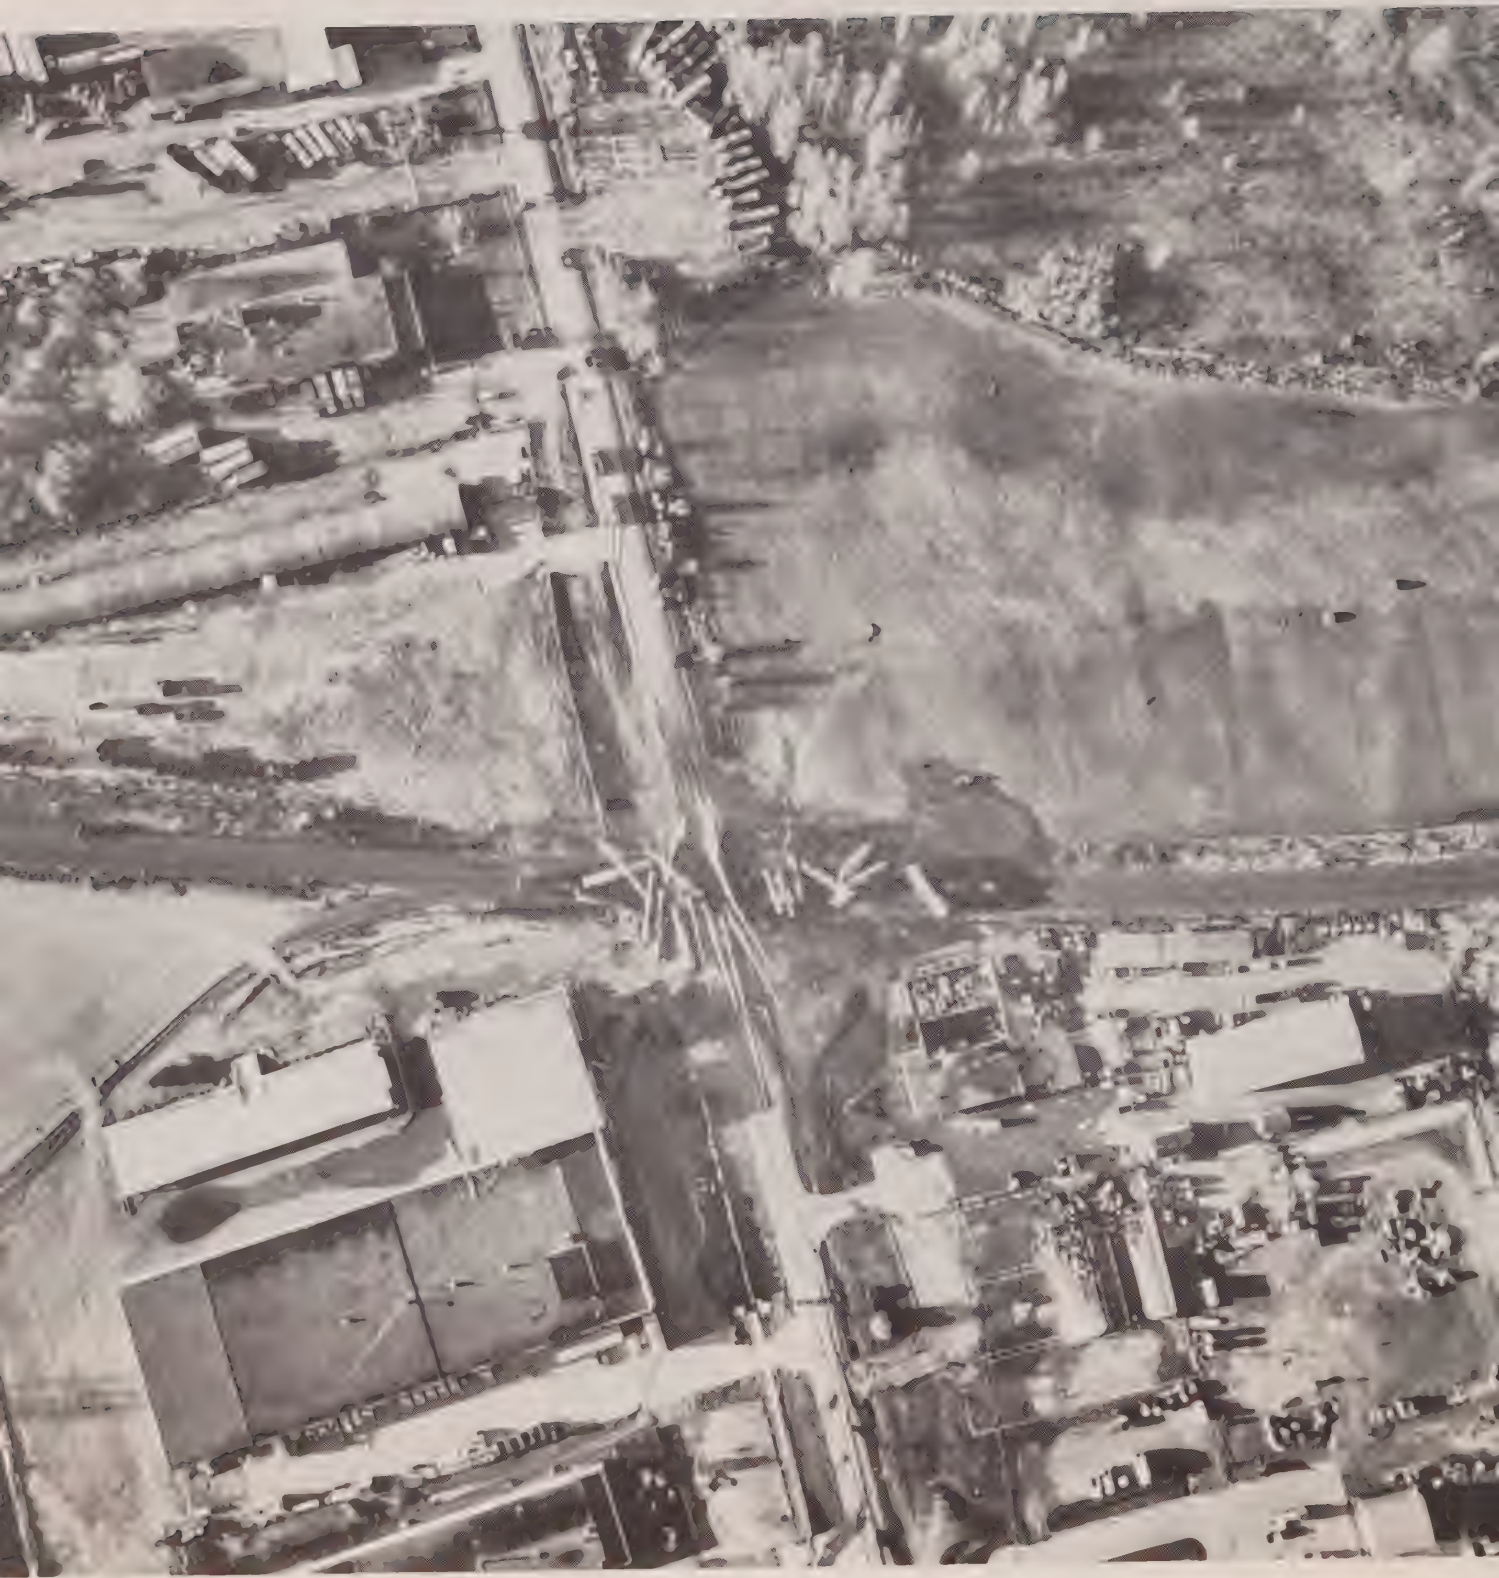
There is really no problem about the cause of the derailment. The Toluene car suffered a "hot box" in its right-rear journal box. Almost all railway cars have eight wheels upon four axles which are numbered one to four from the "B" end of the car. The cars can go in either direction, but for reference purposes one end is labelled "A" and the other "B"; the "B" end is the end where the hand brake is to be found. The axles and wheels are lettered "L" for left and "R" for right looking from B to A. The hot box therefore was in the R1 position. The axles at their extremities are called journals. These journals bear the weight of the car and are housed in journal boxes. The two forward and two rear axles are connected by side frames of which the journal boxes are a part and the whole assembly in front is called the leading truck and the whole assembly behind is called the trailing truck. Inside the journal boxes are bearings resting upon the constantly revolving journals. Some of these bearings—the modern ones—are roller bearings, but the majority and the ones in the Toluene

car (Car 1) were of the friction or plain bearing type. In the plain bearing arrangement a wedge rests upon a brass (the actual bearing) which rests upon the journal with a lubricator pad (soaked in oil) beneath the journal supplying the lubrication which is so sorely needed between the brass and the journal. If for any reason the lubricator pad ceases to perform its task, the bearing and journal will be in direct contact and the journal will start to overheat. Eventually and inevitably if unattended, the journal will burn off and the tank car will collapse. With Car 1 the rear axle, together of course with its two wheels, separated from its truck and the car over a mile short of the derailment site. The car proceeded on its six wheels to and past Erindale Station Road where apparently the front wheels of the trailing truck, i.e. R2 and L2 derailed. The wheels however did not then detach and the car proceeded on its 6 wheels, 4 on the rails and 2 off, almost to Mavis Road where the remaining wheels hit a switch and the whole car derailed. The other 23 cars then followed it off the track.
